Methodologies in Assessing and Repairing Space Analog Research Stations

Andrew J. Greco,*

Florida Institute of Technology, Melbourne FL, United States of America

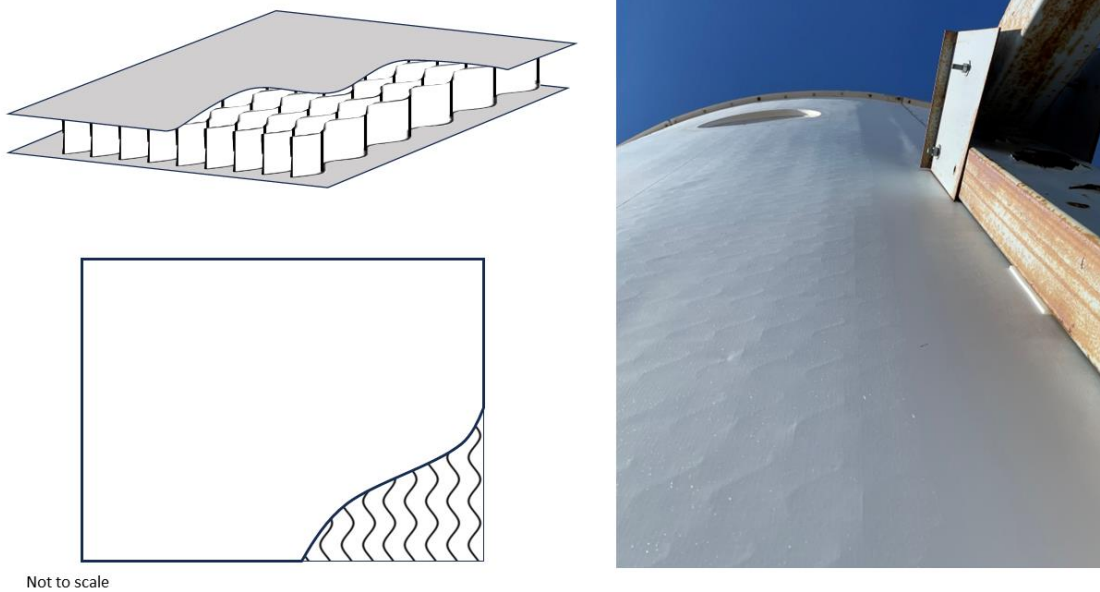
The MARS primary structure is a combination of fiberglass composite, wood floors, and steel support legs. The bulk of the weight of the structure is in the composite elements [Ref. Table 2]. Wall panels and ceiling sections are made of a composite layup of glass fiber face sheets with a glass fiber corrugated channel core [Ref. Fig 2, 3].

Fig. 2 Illustration showing composite layup and core shape and orientation typical of the wall and roof panels (Left). A view at a low sun angle shows the corrugations through the exterior face sheet (Right).

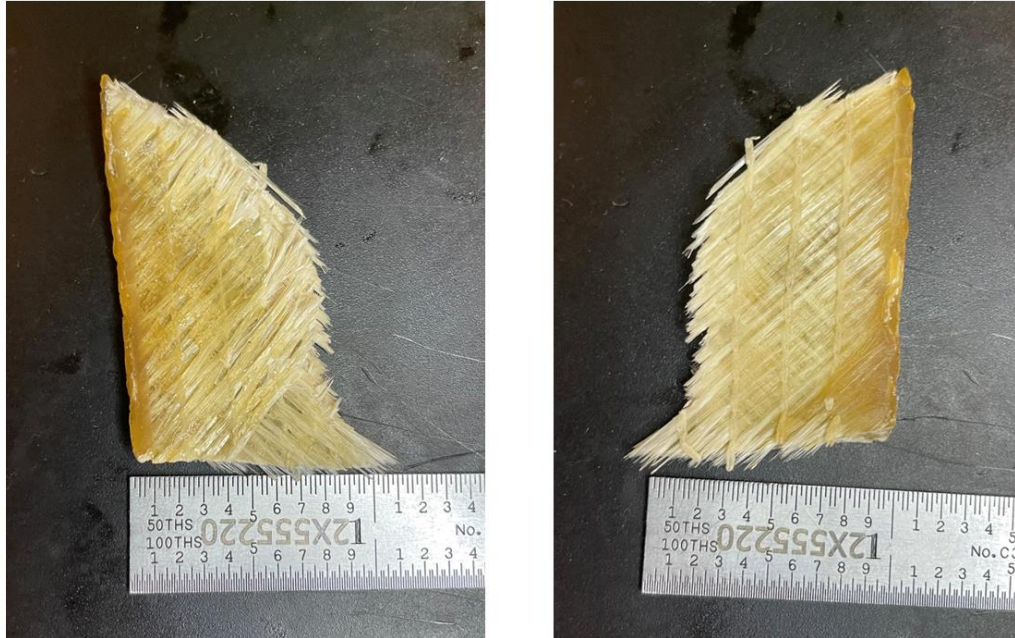
Fig. 3 A sample of the composite from the core section of the wall panel ventilation hole near the Engineering Hatch.
